Morphology And Morphometry Of A Channelized Stream: The Case History Of Big Pine Creek Ditch, Benton County, Indiana, Studies In Fluvial Geomorphology No. 4

MORPHOLOGY AND MORPHOMETRY OF A CHANNELIZED STREAM:
THE CASE HISTORY OF BIG PINE CREEK DITCH, BENTON COUNTY, INDIANA

This is a partial completion report for
OWRT Project No. A-035-IND (Agreement No. 14-34-0001-6015)
entitled "Channel Morphology, Stream Power, and Sediment
Types as Related to Channelization and River Training"

Technical Report No. 92
Purdue University Water Resources Research Center
West Lafayette, Indiana

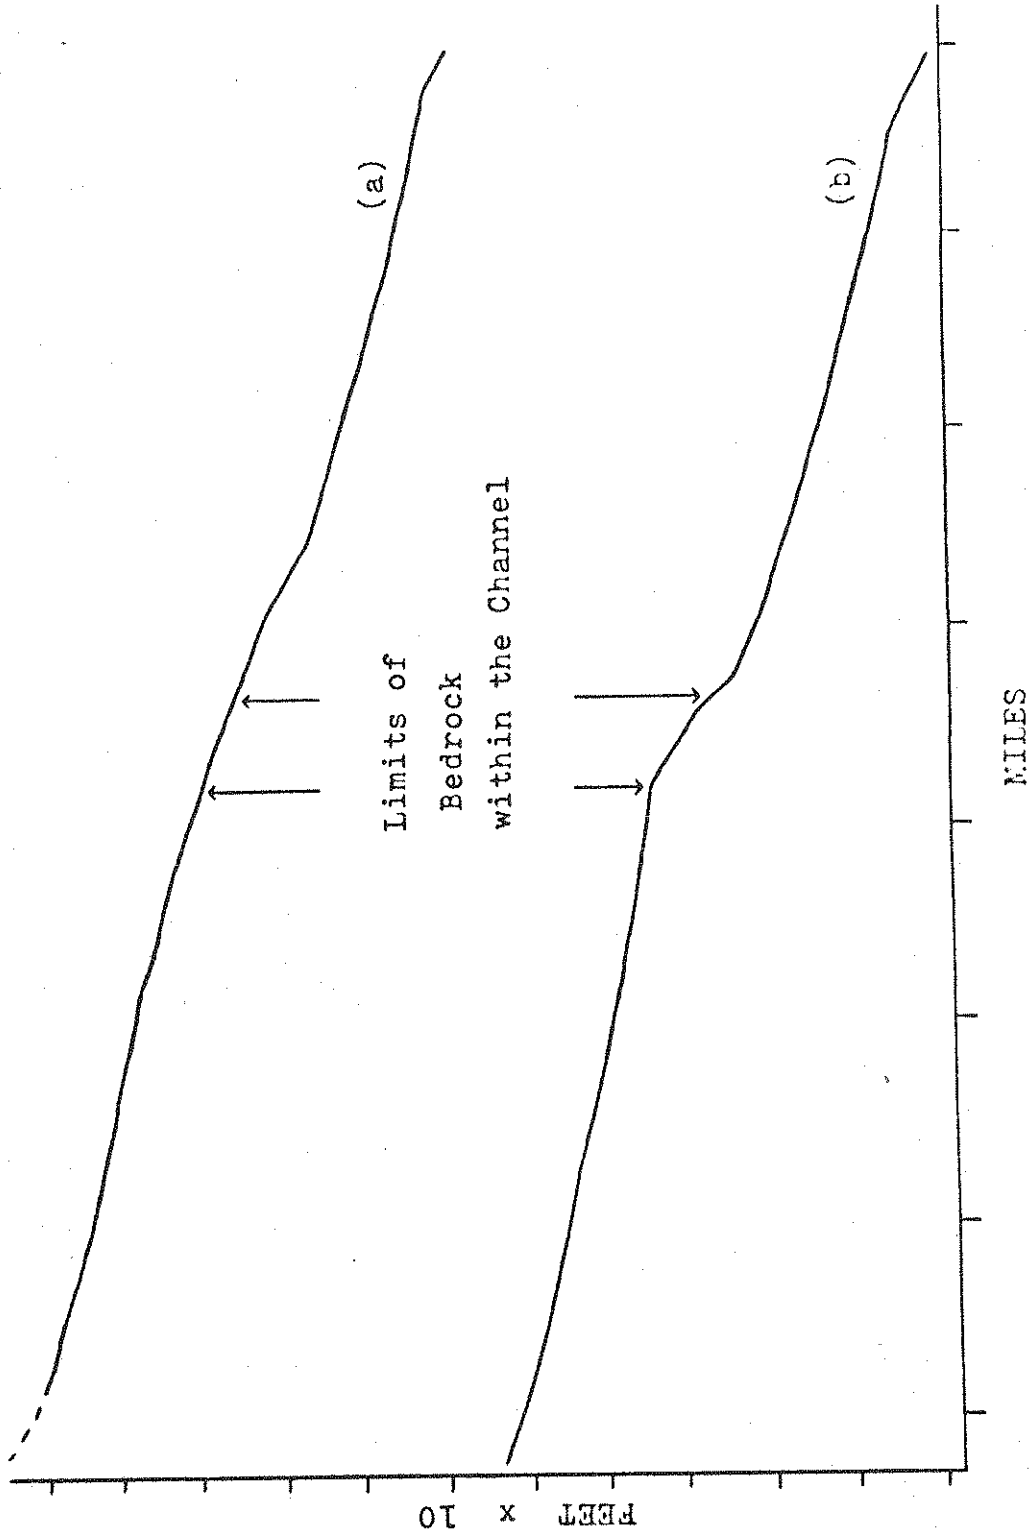
Figure 5 Channel profile of Big Pine Creek Ditch a) after channelization in 1932
(Benton Co. Ditch Docket #137) b) after 30 years of recovery in 1962.

was reduced from 10.1 to 7.2 miles, or by 30 percent, so average gradients were increased from 6.3 (0.00117) to 8.5 (0.00152) ft/mi. Fall of the main stream was reduced by seven feet by entrenchment of the headwater reaches.

There is rather obvious deterioration on the western end of Section 34, which can be explained by the bedrock high in that area. It can also be noted on the channel profile of the stream in 1962 (Figure 5), that a definite steepening of the channel occurs immediately downstream as downcutting was effectively stopped on the bedrock but accelerated below this point. The increase in slope and corresponding stream velocity has apparently caused increased meander development. This development is presently continuing, as demonstrated by the change in channel pattern from 1963 to 1971.

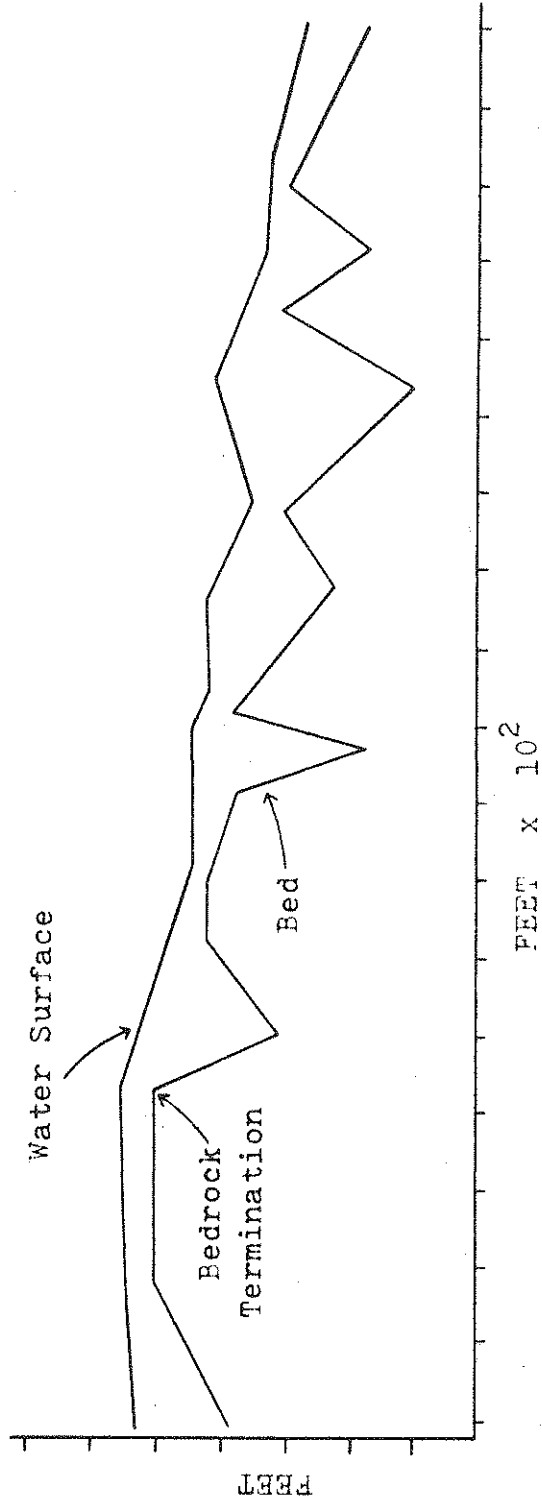
Figure 9 Channel profile of the survey reach indicating advanced stages of pool-riffle development (80X vertical exaggeration).

development accompanying meander adjustments. Note also the knickpoint conditions existing at the bedrock termination.

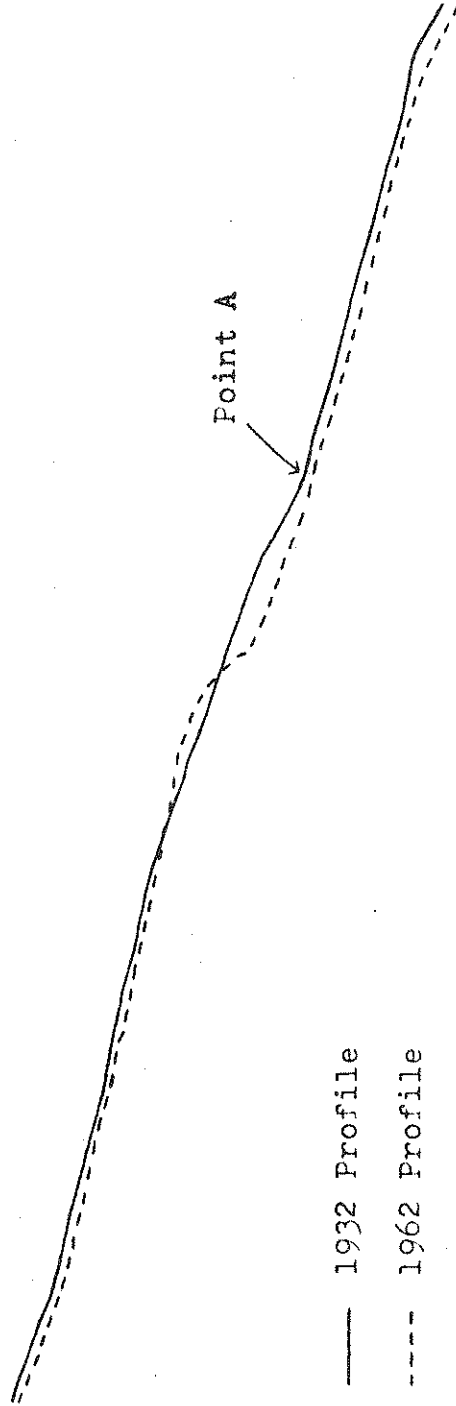
Figure 10 Comparison of 1932 and 1962 profiles of Big Pine Creek Ditch. Scales and endpoints are the same as in Figure 5.

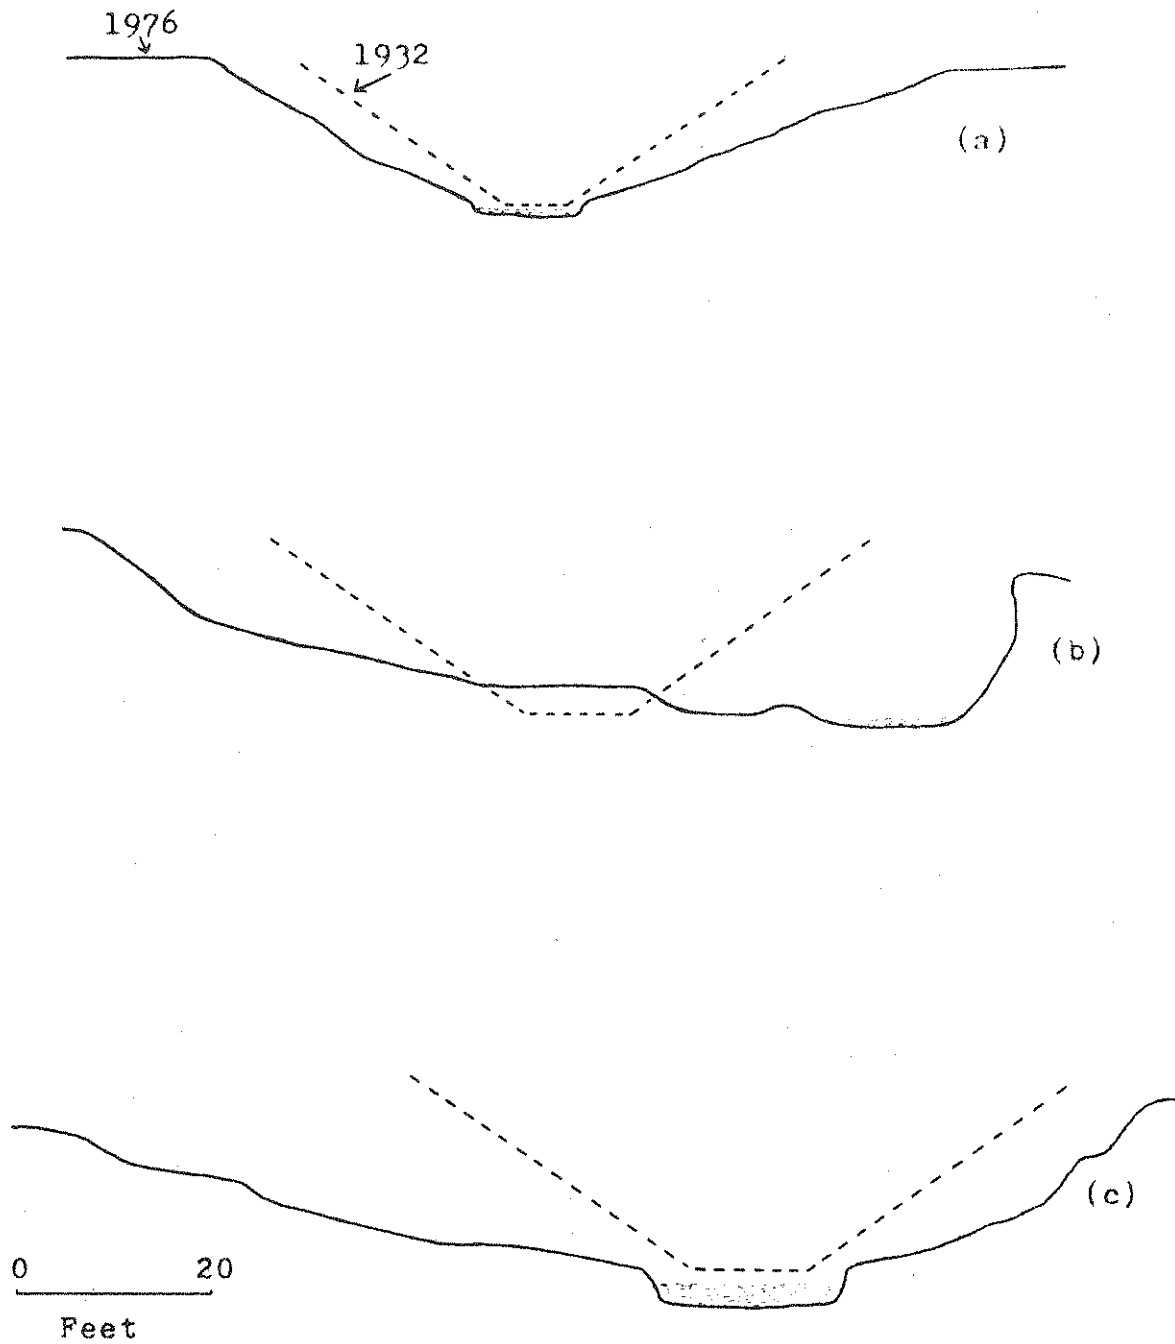
In conversation with local residents in 1975 and 1976, many complained of increased flooding in recent years, both in magnitude of land involved and frequency of flooding. Assuming that discharge has not increased appreciably in 40 years, investigation turned to deterioration of the channel as the cause of these conditions. Cross-sections were made at several points through the seven mile study reach, and these include areas of only slight deterioration, and those showing greater amounts. Figure 13a was constructed in Section 24, quite close to the headwaters and thus shows only minor changes since 1932 (see Figure 14). Figure 13b conversely shows considerable bank slumping, collapse, and deposition on the inside of meander bends.

These cross-sections were made in both straight and meandering reaches to show the differing types of degeneration: that is, slow slumping and creep of banks in the straight reaches, and lateral migration of channel and meanders,

Figure 13 Cross-sections in: a) Section 24, T26N, R8W,
b) Section 34, T26N, R7W (downstream end)
c) Section 1, T25N, R7W, 0.5 mi upstream from
outlet. (these cross-sections are approximations)

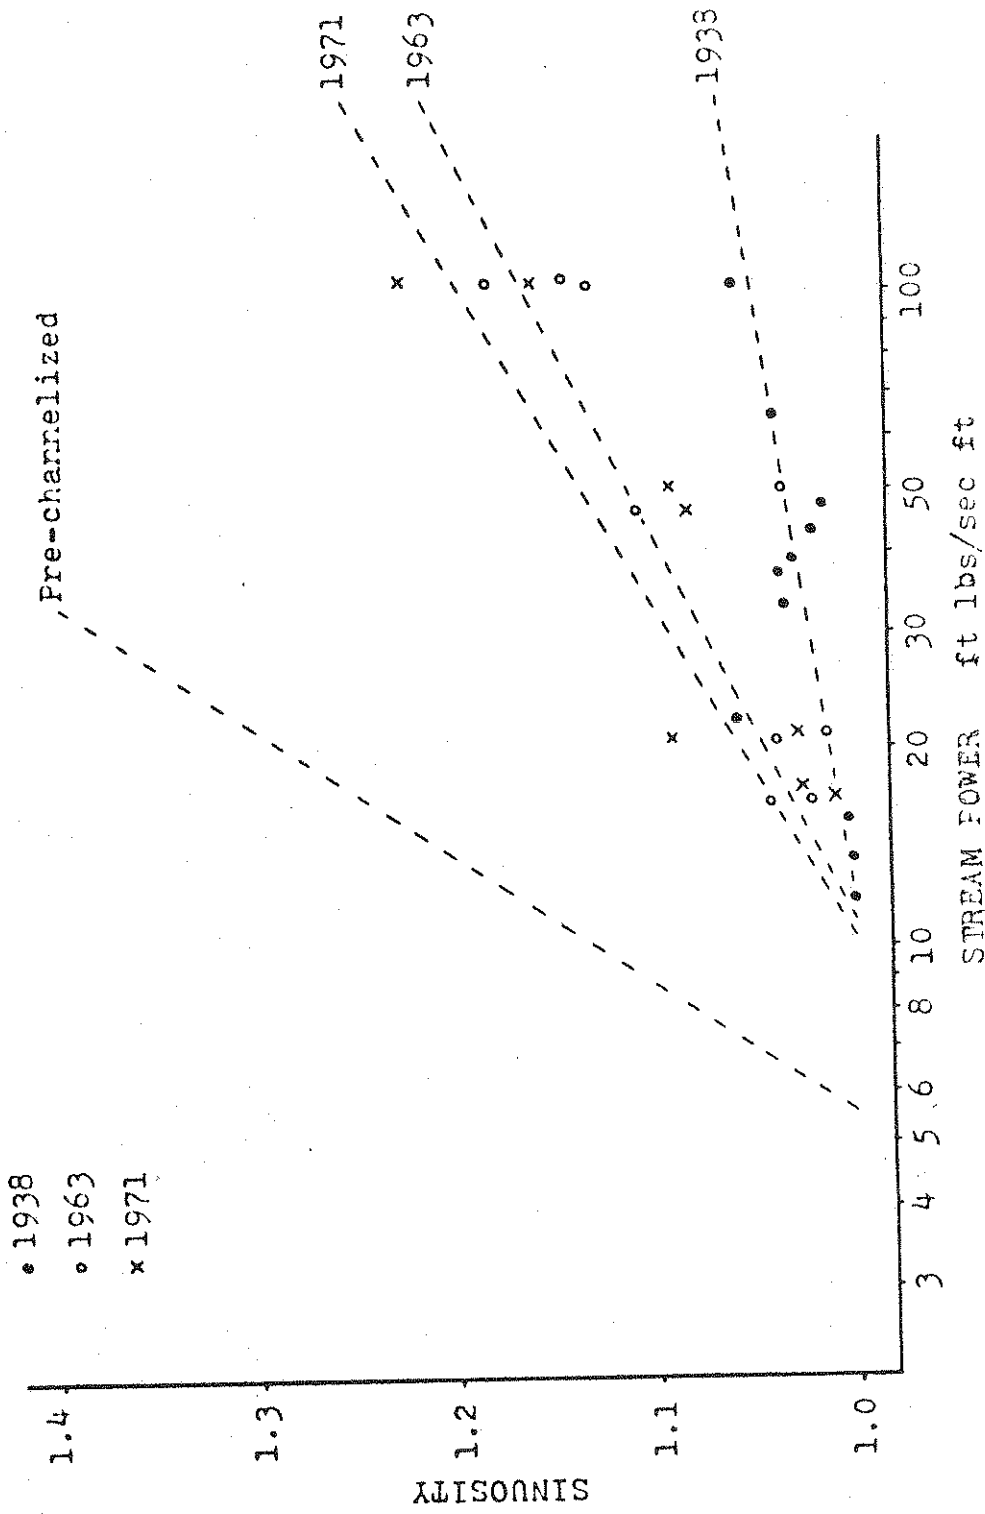
Figure 26 Variations of sinuosity with stream power on Big Pine Creek Ditch in 1938, 1963, and 1971.

process of curve fitting through these points is more difficult than on the pre-channelized stream, definite trends exist. Some very low points can be eliminated, as they are very possibly caused by the interim maintenance measures performed by the local residents. Such maintenance has most definitely affected the channel in several sections.

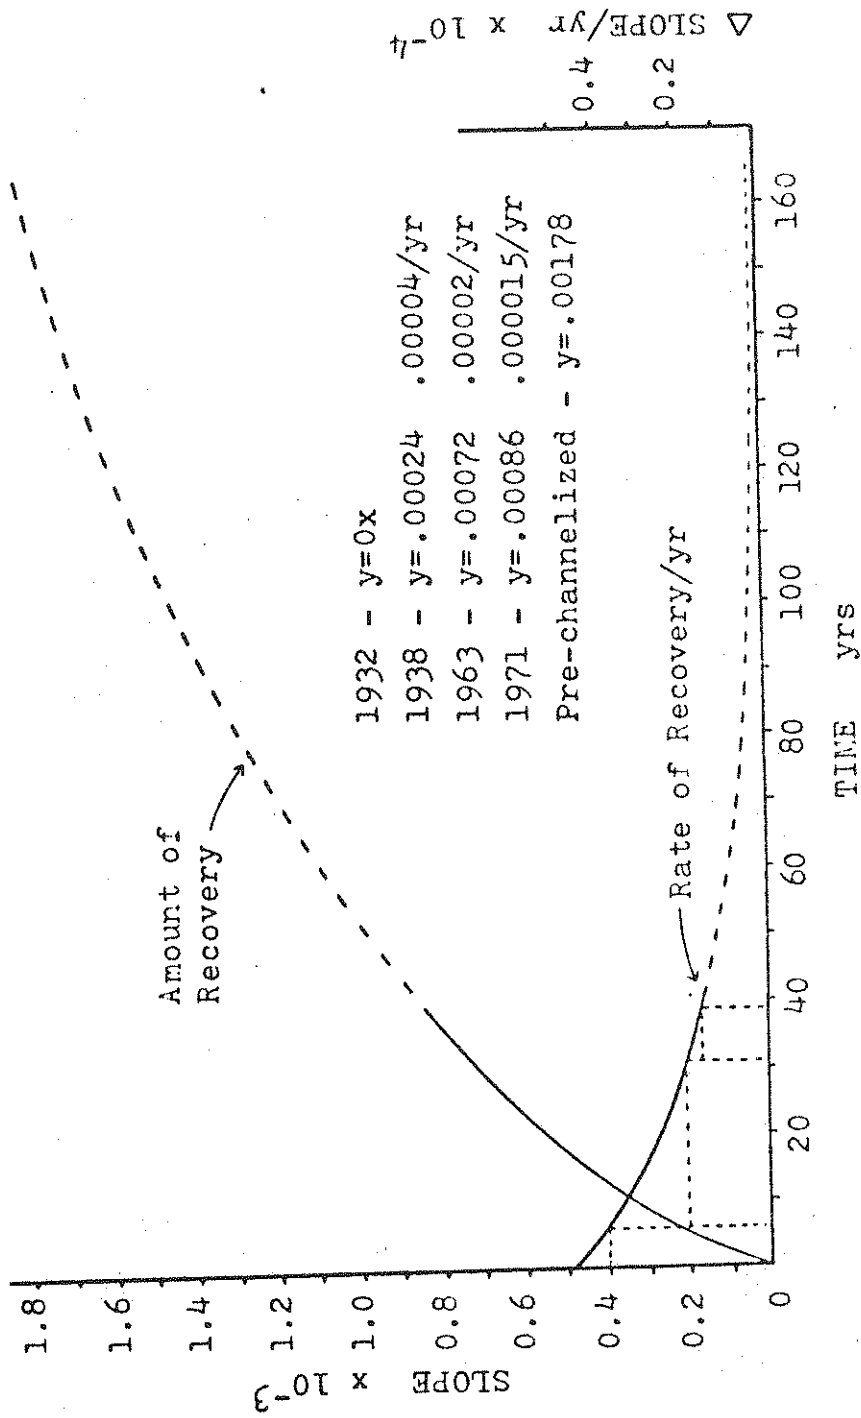
semi-log paper, appear closer to straight lines) for the time period under consideration. These slopes were subsequently plotted against time, and appear as a curve in Figure 27. Extension of this curve to the slope of the pre-channelized stream power vs. sinuosity line would thus give some idea about the time required for the stream to regain equilibrium conditions. The graph shows that by the year 2080, or after 165 years of recovery, Big Pine Creek Ditch, if allowed to deteriorate under natural conditions, would again be in a quasi-equilibrium state.

Figure 27 Estimation of amounts of recovery with time and rates of recovery with time, from channelization in 1932 until total recovery after 165 years.
